City of Baltimore Wet Smoke and Dyed	Page 1 of 2	
Sewershed: Gwynns Falls	Company: Savin	Date: 4/23/2009
Test to be performed: Ground Condition: Smoke Dyed Water X Dry ✓ Damp Wet		Supervisor: JAW
Manhole_ID: S03SS_002MH	Test ID: <u>D1032-022047</u>	Notification Made: NA (Residents, Fire, 311)

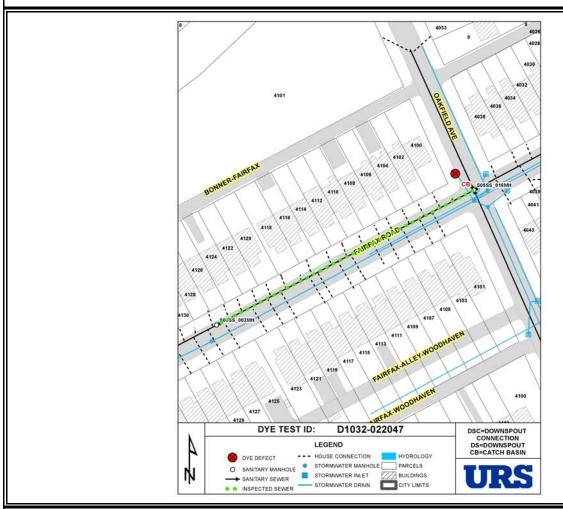
Field Sketch: Show all manholes with Numbers, Blower Placement Locations, Sandbag or Isolation Locations, Street Names, Building Addresses and Locations, Defect Locations and Photo Numbers.

Defect Loc	Obs_ClockFrom	Obs_ClockTo Observation	on Obs_Remarks
0		Manhole	S05SS_016MH
4		Dye Test V	isible @ IR, 0.1gpm
7		Dye Test V	isible @ IR, 0.2gpm
10.10000038		Dye Test V	isible @ IR, <0.1gpm
13		Dye Test V	isible @ IR, 0.1gpm
16.29999924		Dye Test V	isible @ IR, 0.5gpm
19.39999962		Dye Test V	isible @ IR, 0.1gpm
22.39999962		Dye Test V	isible @ IR, 0.1gpm
26.5		Dye Test V	isible @ IR, 0.2gpm
29.39999962		Dye Test V	isible @ IR, 0.1gpm
30.29999924	02	Tap Factor	y Active 0.1gpm
